**Flood Control Project Maintenance
Levee Inspections**

Fall 2010 Levee Maintenance Deficiency Summary Report

San Joaquin River Basin

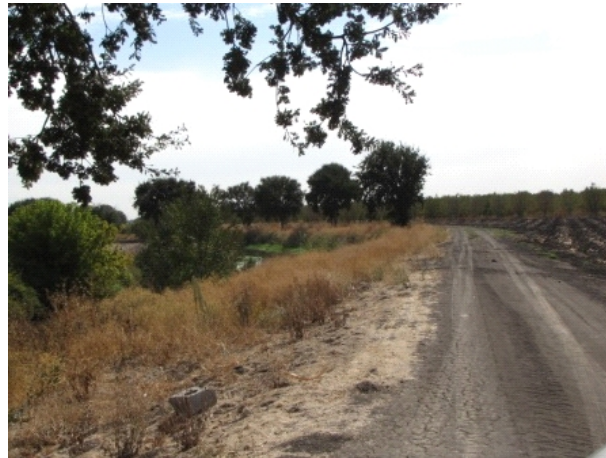
dpesaven_f_20101006_461.jpg

View of vegetation on the waterward side of the levee blocking visibility looking upstream.

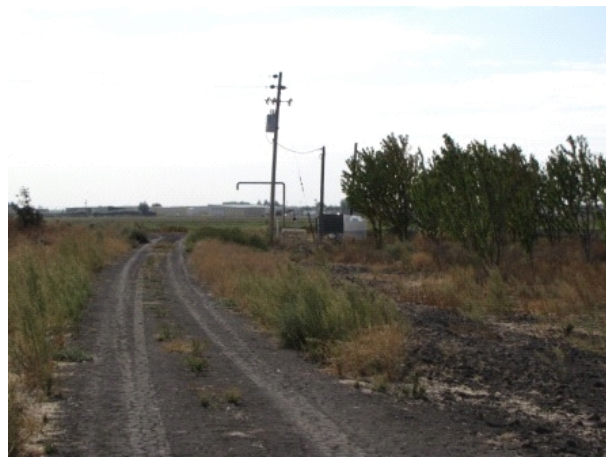
dpesaven_f_20101006_462.jpg

Levee Mile Report Line	2
Start Levee Mile	0.01
End Levee Mile	0.49
Location	Land Side
Category	Earthen Levee
Item	Vegetation

View of vegetation on the landward slope blocking visibility looking upstream.

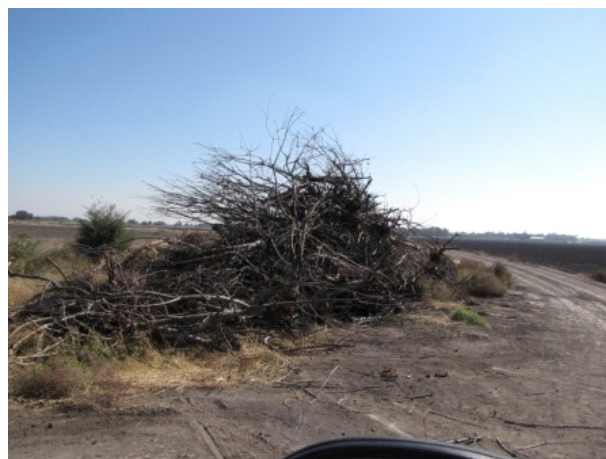
dpesaven_f_20100928_007.jpg

Levee Mile Report Line	3
Start Levee Mile	0.42
End Levee Mile	0.42
Location	Water Side
Category	Earthen Levee
Item	Encroachments

View of a prunings pile on the waterward side of the levee looking upstream.

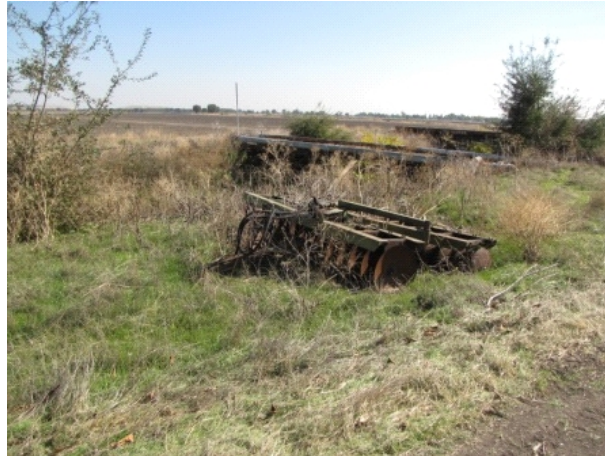
dpesaven_f_20100928_006.jpg

View of equipment on the waterward side of the levee looking upstream.

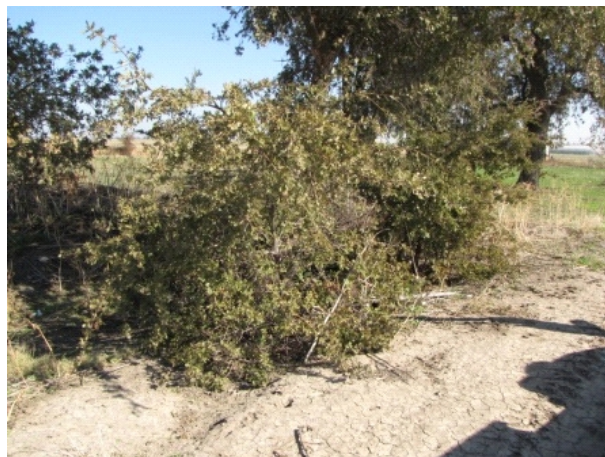
dpesaven_f_20100928_003.jpg

View of tree branches blocking visibility and access on the waterward side of the levee looking upstream.

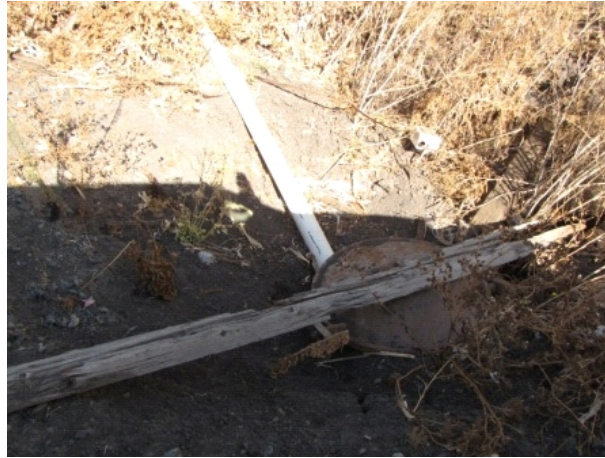
dpesaven_f_20101006_460.jpg

View of a flap gate propped open with a pipe passing through on the waterward side of the levee.

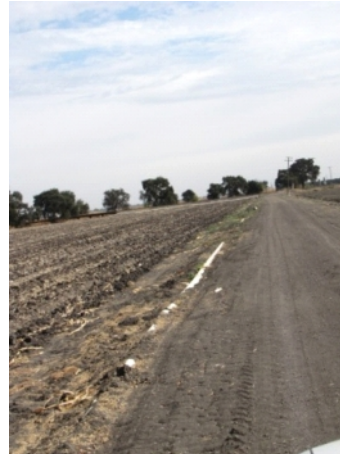
dpesaven_f_20101006_459.jpg

Levee Mile Report Line	12
Start Levee Mile	1.07
End Levee Mile	1.27
Location	Water Side
Category	Earthen Levee
Item	Encroachments

View of a pipe placed in the waterward slope of the levee looking upstream.

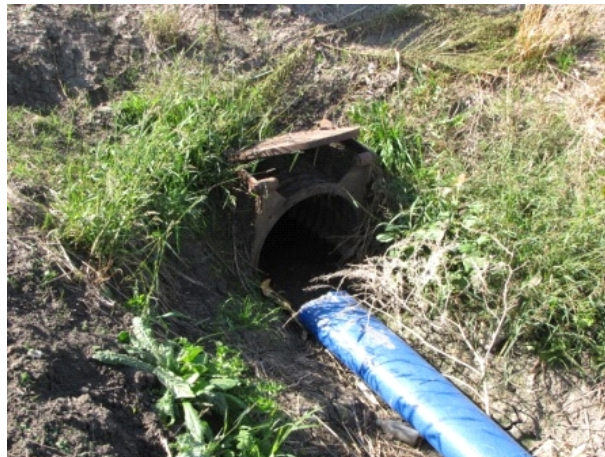
dpesaven_f_20100928_002.jpg

View of a blocked flap gate on the waterward side of the levee. Debris and sediment prevent this gate from closing.

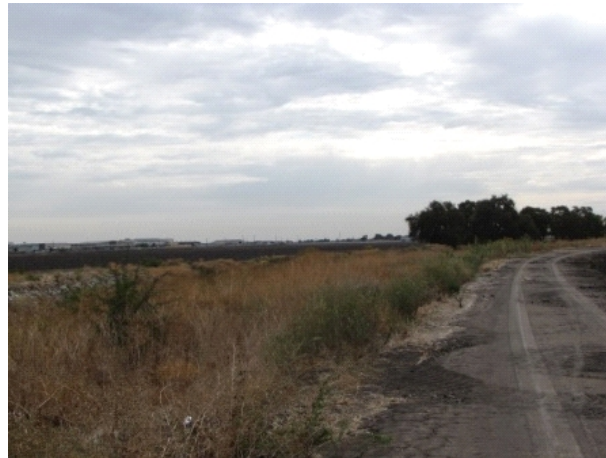
dpesaven_f_20101006_458.jpg

View of vegetation on the waterward slope blocking visibility looking upstream.

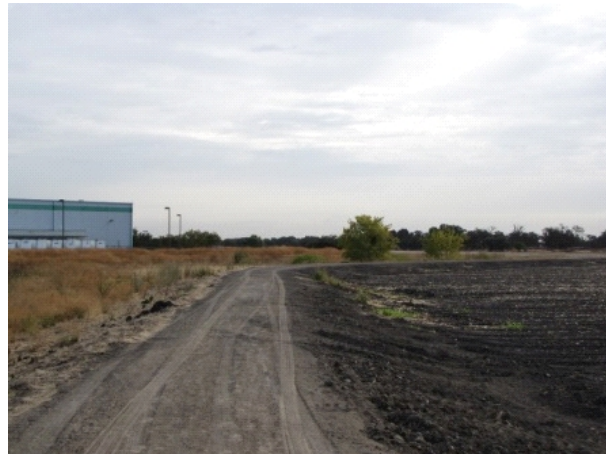
dpesaven_f_20101006_456.jpg

Levee Mile Report Line	18
Start Levee Mile	1.60
End Levee Mile	2.85
Location	Land Side
Category	Earthen Levee
Item	Encroachments

View of landowner performed tilling on the landward slope of the levee looking upstream.

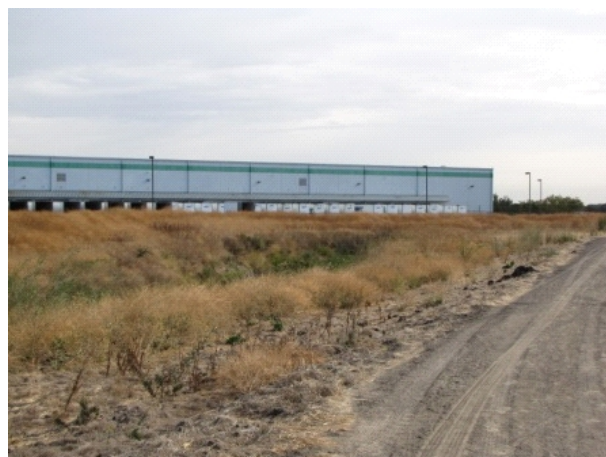
dpesaven_f_20101006_457.jpg

Levee Mile Report Line	21
Start Levee Mile	1.97
End Levee Mile	2.85
Location	Water Side
Category	Earthen Levee
Item	Encroachments

View of slightly older tilling on the waterward side and slope looking upstream.

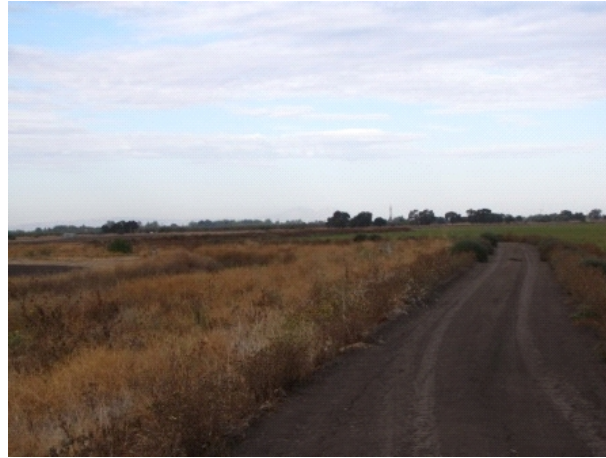
dpesaven_f_20101006_451.jpg

View of vegetation on the waterward side blocking visibility looking downstream.

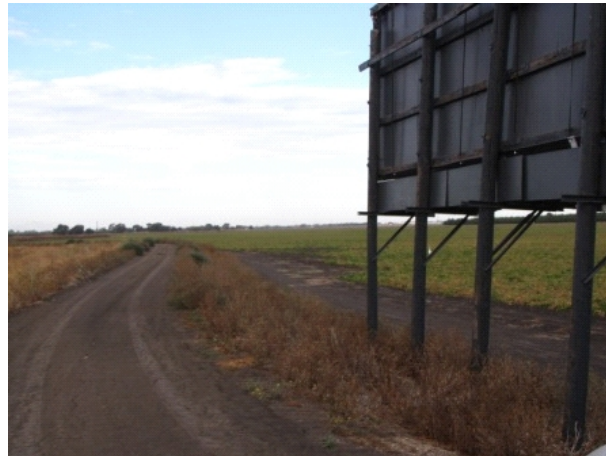
dpesaven_f_20101006_450.jpg

Levee Mile Report Line	2
Start Levee Mile	0.01
End Levee Mile	1.09
Location	Land Side
Category	Earthen Levee
Item	Vegetation

View of vegetation on the landward slope blocking visibility looking downstream.

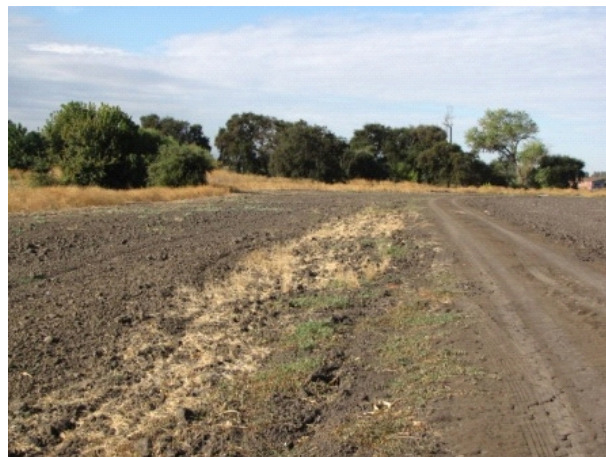
dpesaven_f_20101006_452.jpg

Levee Mile Report Line	4
Start Levee Mile	1.56
End Levee Mile	1.73
Location	Water Side
Category	Earthen Levee
Item	Encroachments

View of landowner's tilling on the waterward side and slope of the levee looking downstream.

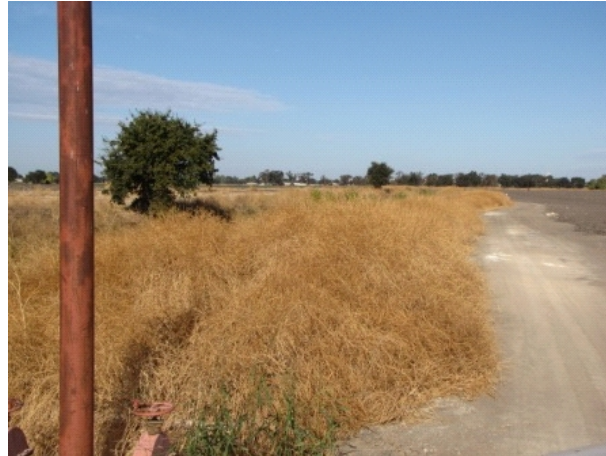
Levee Mile Report Line	6
Start Levee Mile	1.92
End Levee Mile	3.20
Location	Water Side
Category	Earthen Levee
Item	Vegetation
View of vegetation blocking visibility on the waterward slope looking downstream.	
dpesaven_f_20101006_453.jpg

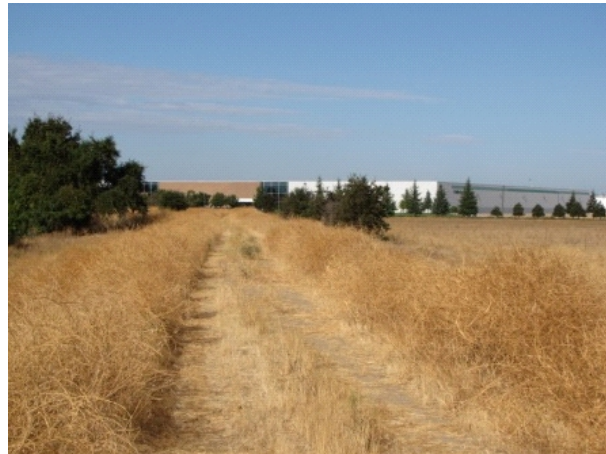
Levee Mile Report Line	8
Start Levee Mile	2.60
End Levee Mile	3.20
Location	Land Side
Category	Earthen Levee
Item	Vegetation
View of vegetation on the waterward and landward slopes and the crown blocking visibility and access looking downstream.	
dpesaven_f_20101006_454.jpg

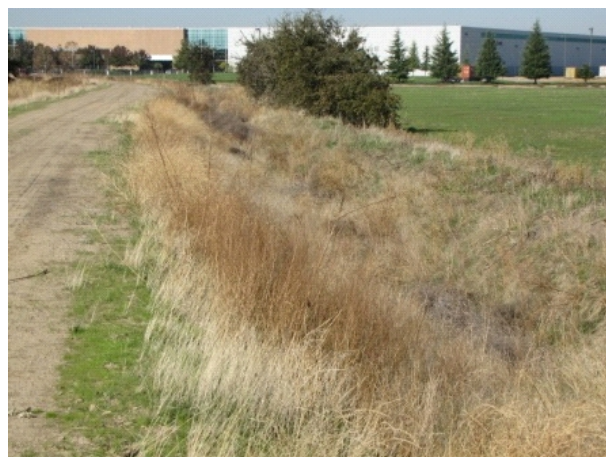
Levee Mile Report Line	9
Start Levee Mile	2.66
End Levee Mile	3.17
Location	Land Side
Category	Earthen Levee
Item	Encroachments
View of an agricultural ditch on the landward side of the levee looking downstream.	
dpesaven_f_20100928_012.jpg

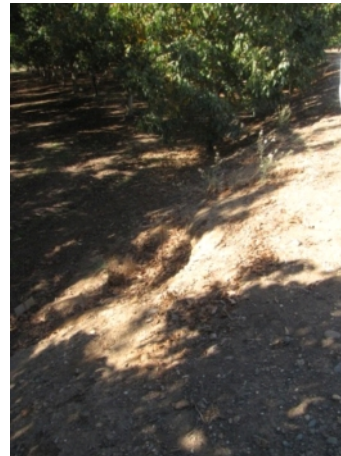
dpesaven_f_20101014_483.jpg

Levee Mile Report Line	3
Start Levee Mile	0.30
End Levee Mile	0.30
Location	Land Side
Category	Earthen Levee
Item	Erosion / Bank Caving

View of a depression in the landward slope looking downstream.

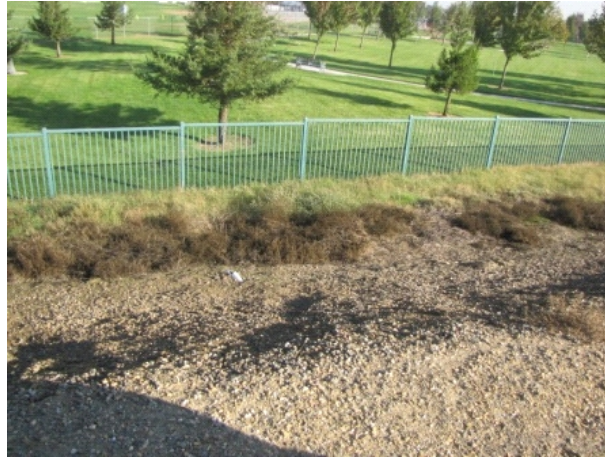
dpesaven_f_20101104_504.jpg

View of the end of a 4" PVC pipe in the landward slope of the levee looking landward and upstream.

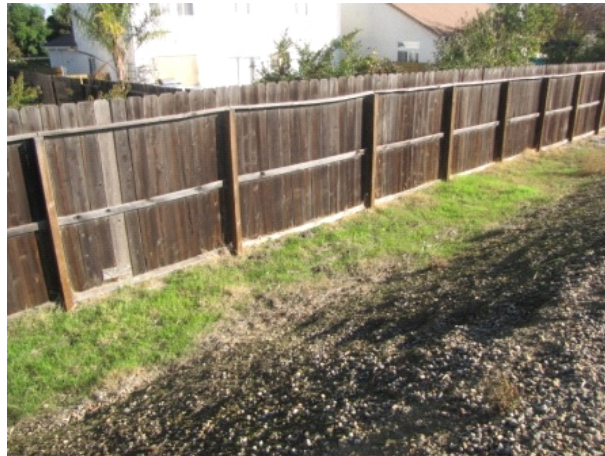
dpesaven_f_20101104_505.jpg

Levee Mile Report Line	5
Start Levee Mile	0.81
End Levee Mile	0.81
Location	Land Side
Category	Earthen Levee
Item	Encroachments

View of steps dug into the landward slope of the levee looking upstream.

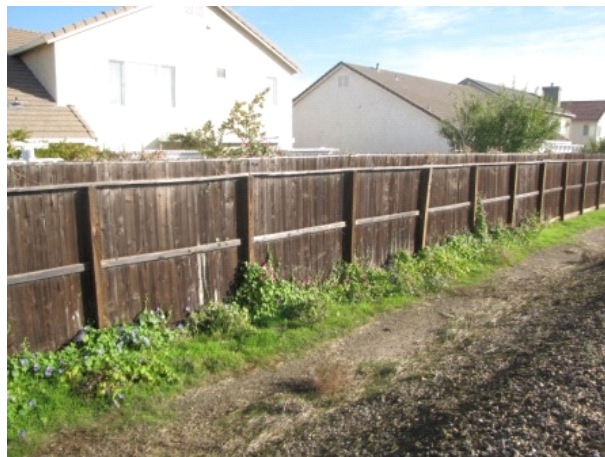
dpesaven_f_20101104_506.jpg

Levee Mile Report Line	17
Start Levee Mile	1.30
End Levee Mile	1.30
Location	Land Side
Category	Earthen Levee
Item	Encroachments

View of landscaping blocking visibility within 10' of the landward toe of the levee looking upstream.

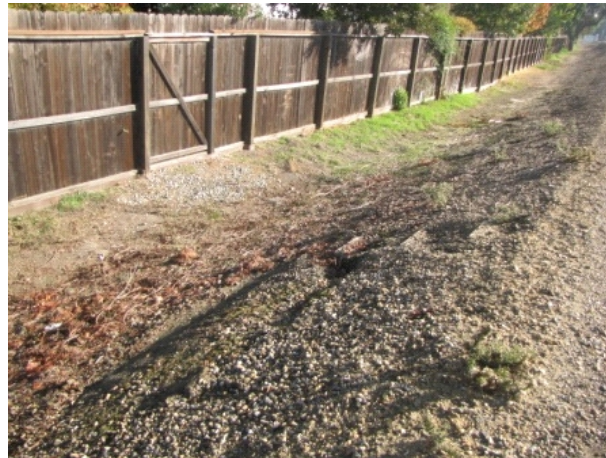
dpesaven_f_20101104_507.jpg

View of steps dug into the landward slope of the levee looking upstream.

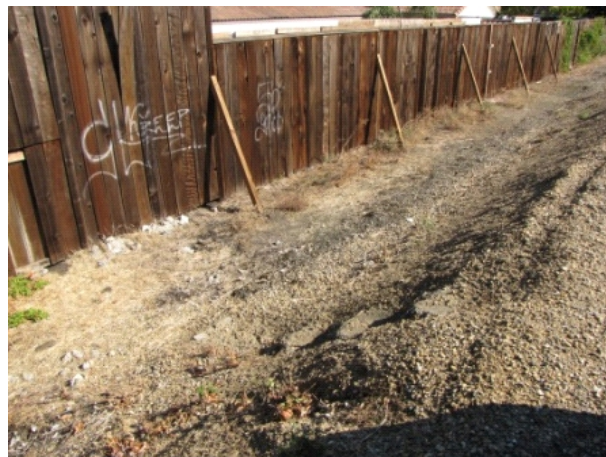
dpesaven_f_20100928_047.jpg

Levee Mile Report Line	26
Start Levee Mile	1.68
End Levee Mile	1.68
Location	Land Side
Category	Earthen Levee
Item	Encroachments

View of unauthorized steps dug into the landward slope looking upstream.

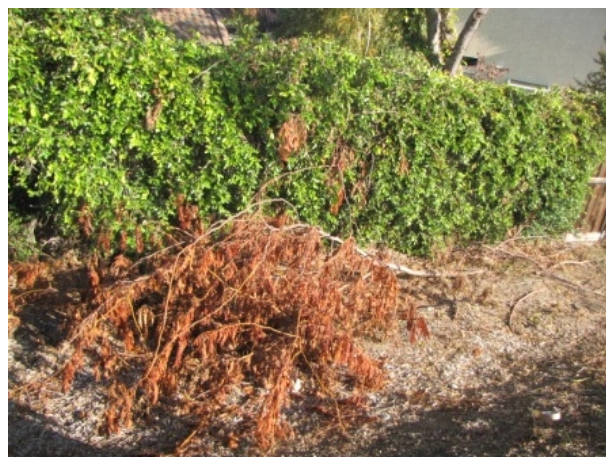
dpesaven_f_20101104_509.jpg

Levee Mile Report Line	27
Start Levee Mile	1.71
End Levee Mile	1.71
Location	Land Side
Category	Earthen Levee
Item	Encroachments

View of a tree limb at the landward toe of the levee looking landward and upstream.

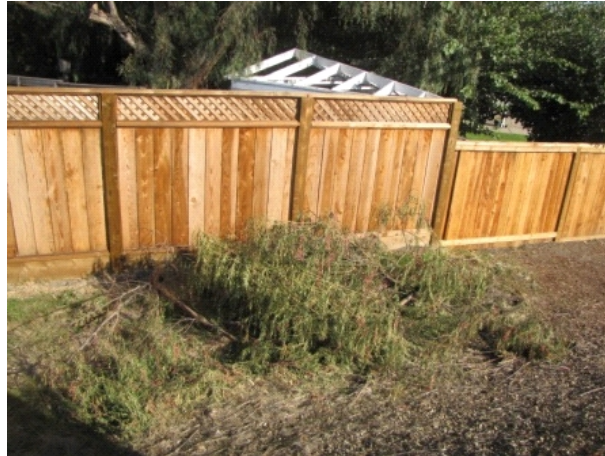
Levee Mile Report Line	28
Start Levee Mile	1.73
End Levee Mile	1.73
Location	Land Side
Category	Earthen Levee
Item	Encroachments
View of tree limbs at the landward toe looking landward and upstream.	
dpesaven_f_20101104_510.jpg

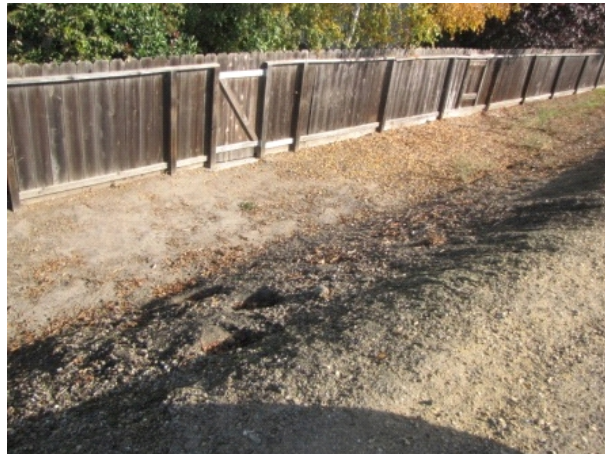
Levee Mile Report Line	38
Start Levee Mile	2.13
End Levee Mile	2.13
Location	Land Side
Category	Earthen Levee
Item	Encroachments
View of steps dug into the landward slope of the levee looking upstream.	
dpesaven_f_20101104_511.jpg

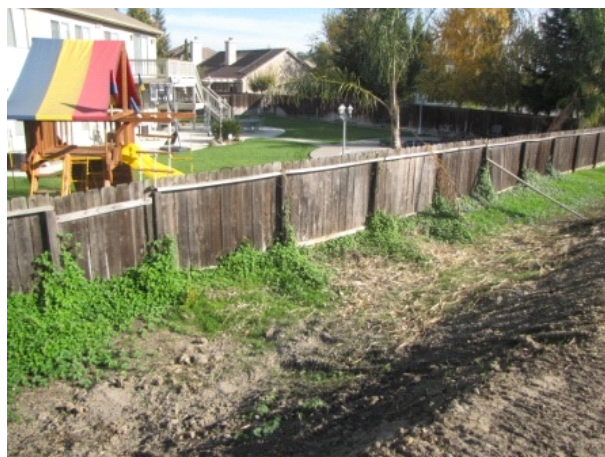
Levee Mile Report Line	50
Start Levee Mile	2.30
End Levee Mile	2.30
Location	Land Side
Category	Earthen Levee
Item	Encroachments
View of landscaping coming through the fence and blocking visibility within 10' of the landward toe looking upstream.	
dpesaven_f_20101104_512.jpg

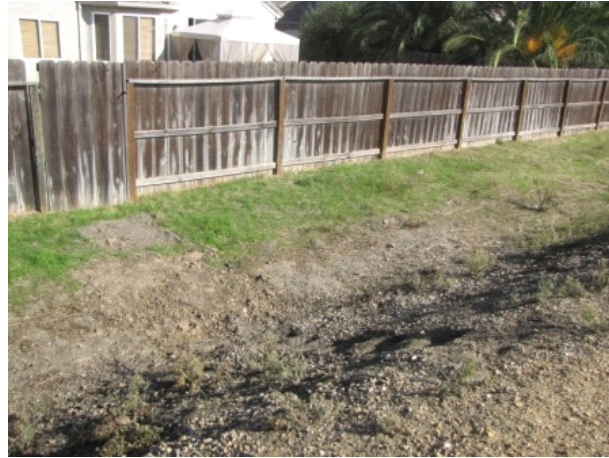
dpesaven_f_20101104_513.jpg

View of steps dug into the landward slope of the levee looking landward and upstream.

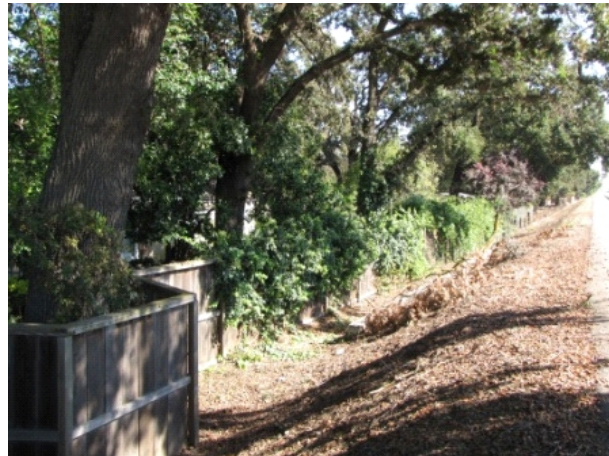
dpesaven_f_20100928_074.jpg

Levee Mile Report Line	59
Start Levee Mile	2.57
End Levee Mile	2.65
Location	Land Side
Category	Earthen Levee
Item	Encroachments

View of a wood fence adjacent to the landward toe looking upstream.

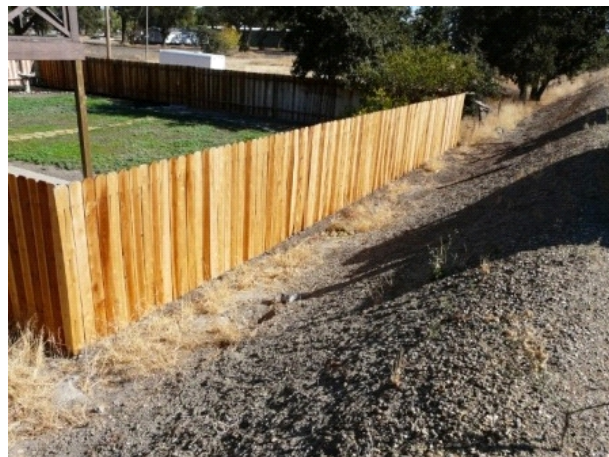
dpesaven_f_20100928_022.JPG

Levee Mile Report Line	60
Start Levee Mile	2.66
End Levee Mile	2.67
Location	Land Side
Category	Earthen Levee
Item	Encroachments

Newer fence built within landside toe of levee at from LM 2.66 to LM 2.67.

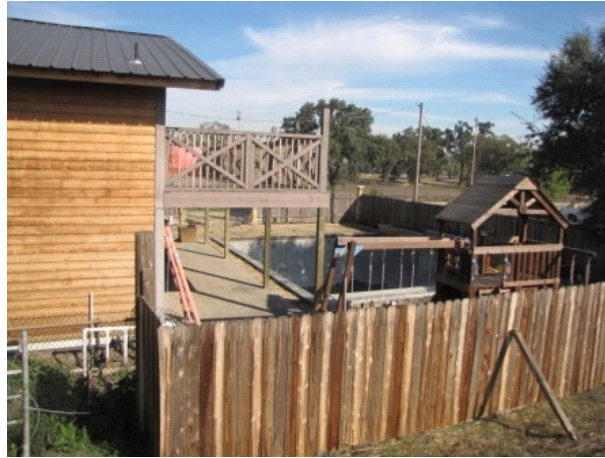
dpesaven_f_20101104_514.jpg

View of a recently constructed pool looking landward.

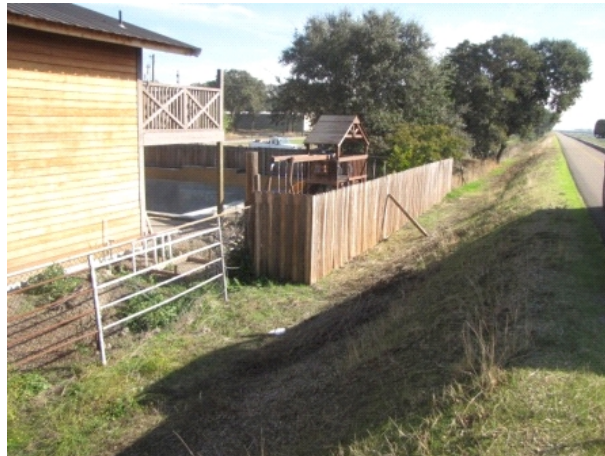
dpesaven_f_20101104_515.jpg

Levee Mile Report Line	61
Start Levee Mile	2.67
End Levee Mile	2.67
Location	Land Side
Category	Earthen Levee
Item	Encroachments

View of a recently constructed pool looking upstream.

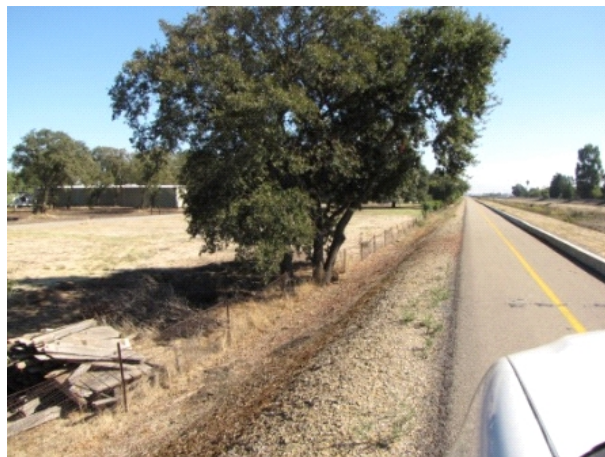
dpesaven_f_20100928_075.jpg

Levee Mile Report Line	62
Start Levee Mile	2.68
End Levee Mile	3.04
Location	Land Side
Category	Earthen Levee
Item	Encroachments

View of a metal fence adjacent to the landward toe looking upstream.

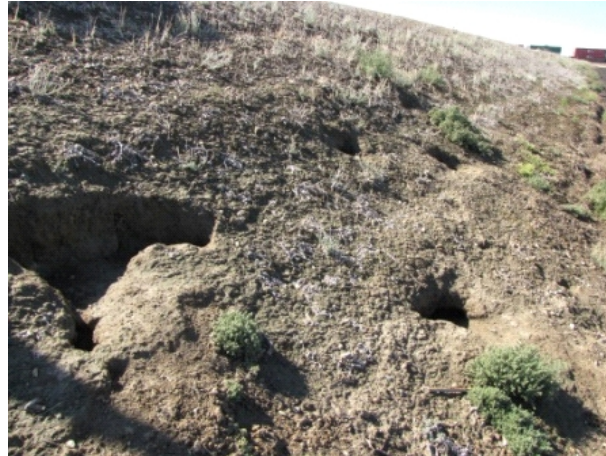
dpesaven_f_20100928_076.jpg

View of rodent holes in the landward slope.

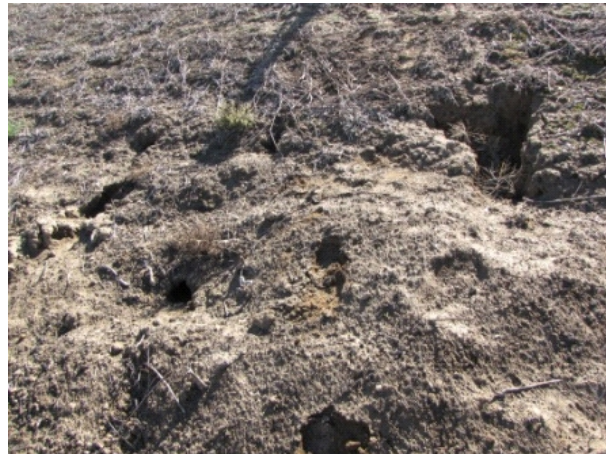
dpesaven_f_20100928_077.jpg

Levee Mile Report Line	70
Start Levee Mile	3.92
End Levee Mile	3.92
Location	Land Side
Category	Earthen Levee
Item	Animal Control

View of rodent holes in the landward slope.

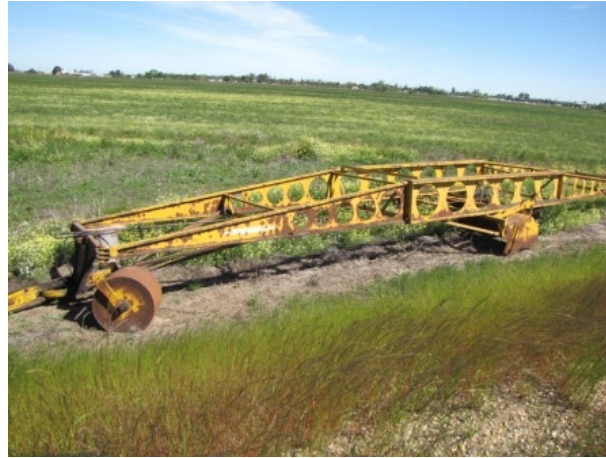
dpesaven_f_20100928_020.jpg

View of farming equipment parked at the toe of the levee.

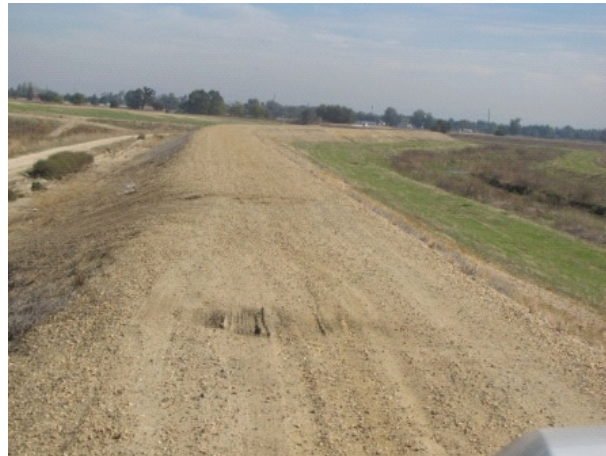
dpesaven_f_20101104_516.jpg

Levee Mile Report Line	76
Start Levee Mile	6.03
End Levee Mile	6.03
Location	Crown
Category	Earthen Levee
Item	Crown Surface / Depressions / Rutting

View of a depression in the crown of the levee looking upstream.

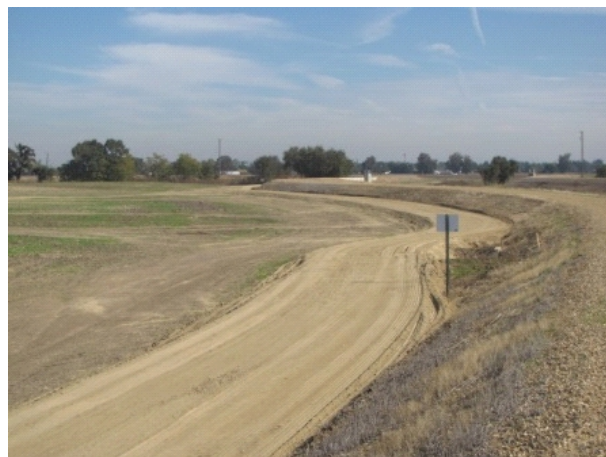
dpesaven_f_20101104_517.jpg

Levee Mile Report Line	77
Start Levee Mile	6.19
End Levee Mile	6.47
Location	Land Side
Category	Earthen Levee
Item	Encroachments

View of soil placed along the landward toe of the levee looking upstream.

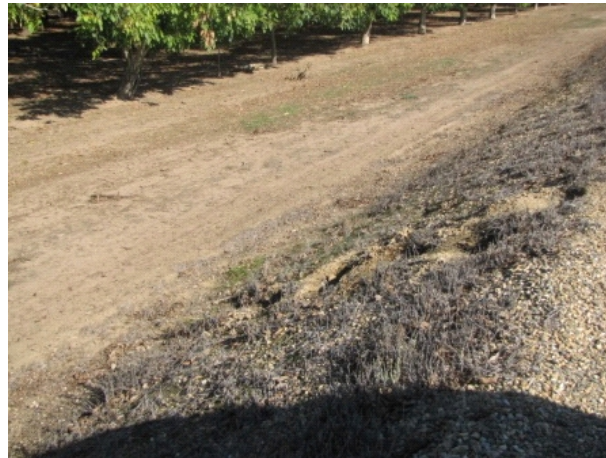
dpesaven_f_20101104_518.jpg

View of steps dug into the landward slope of the levee looking upstream.

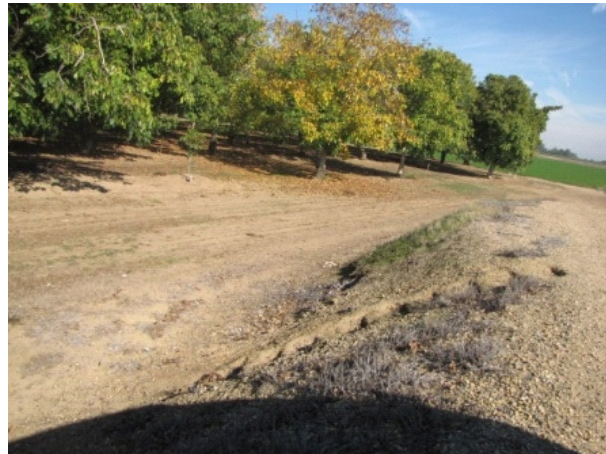
View of steps dug into the landward slope of the levee adjacent to a ramp looking upstream.

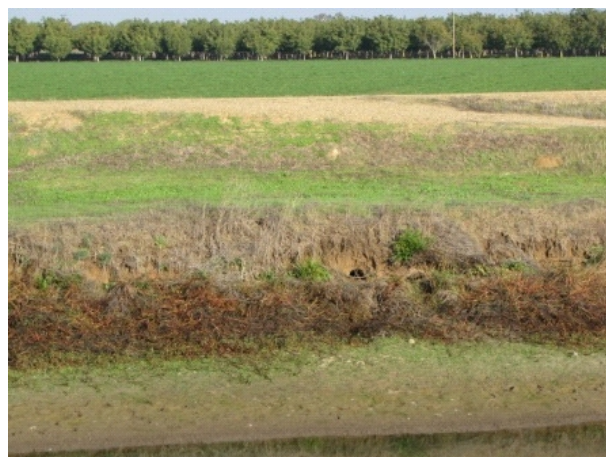
Levee Mile Report Line	90
Start Levee Mile	9.57
End Levee Mile	9.57
Location	Water Side
Category	Earthen Levee
Item	Animal Control

View of a large hole in the waterward berm from across the channel.

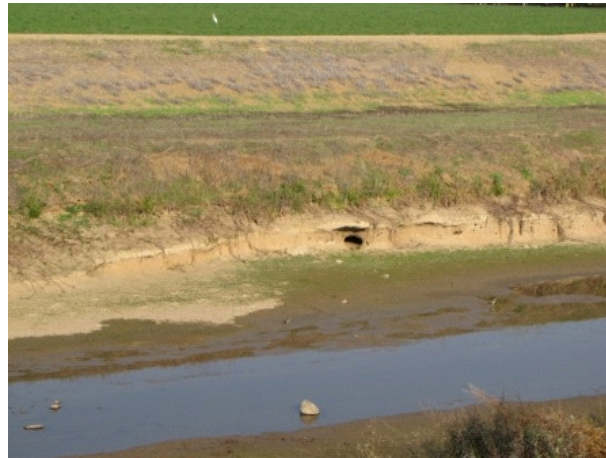
View of a large hole and several smaller holes from across the channel.

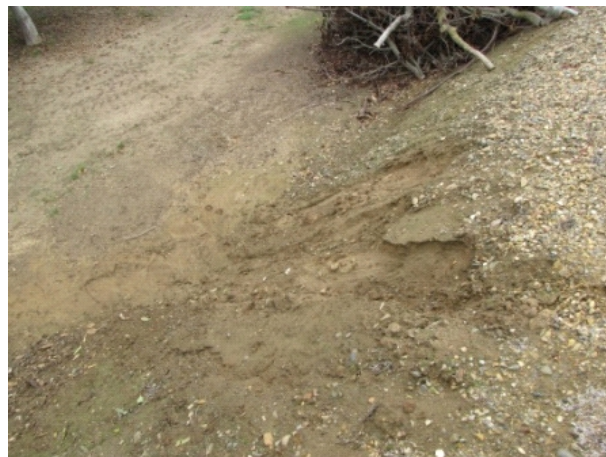
View of erosion occurring on the landward slope.

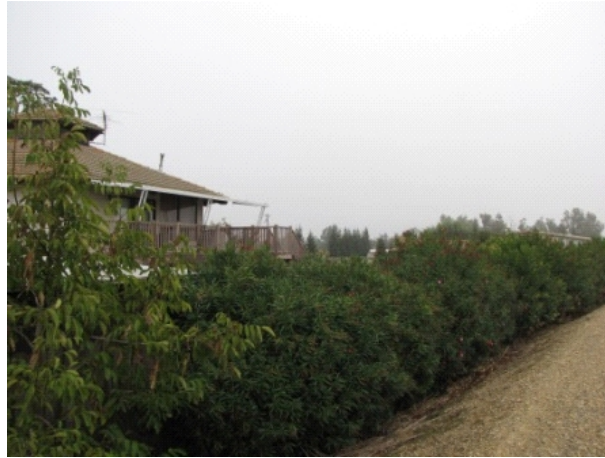
View of landscaping along the landward slope and toe looking upstream.

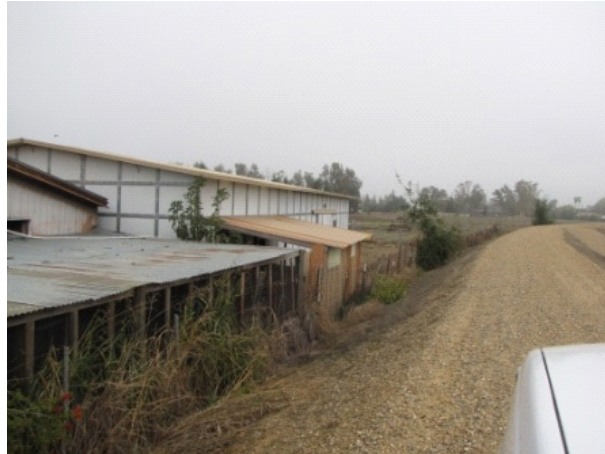
Levee Mile Report Line	103
Start Levee Mile	10.39
End Levee Mile	10.62
Location	Land Side
Category	Earthen Levee
Item	Encroachments

View of a metal fence and structure adjacent to the landward toe looking upstream.

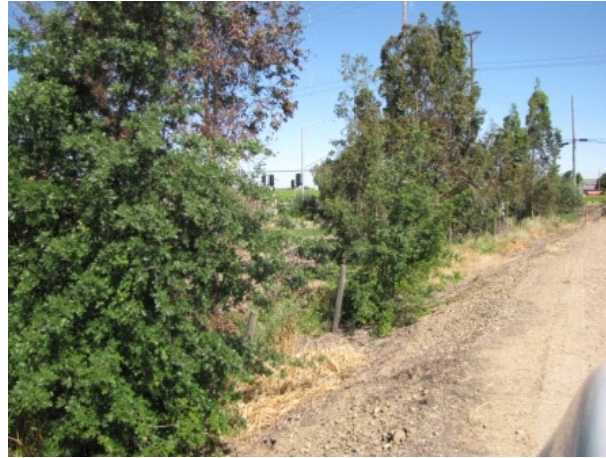
View of trees blocking visibility along the landward toe looking upstream.

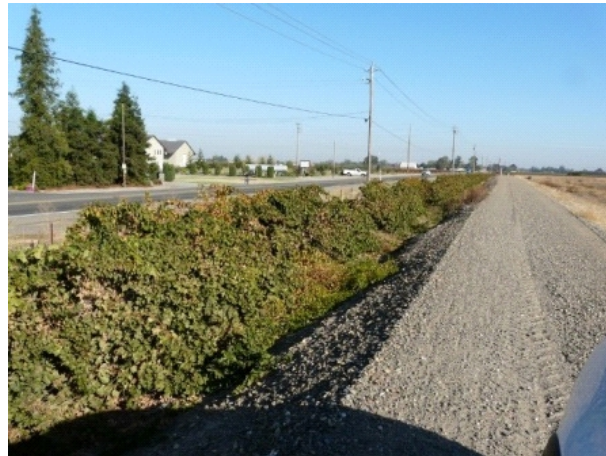
Levee Mile Report Line	119
Start Levee Mile	13.39
End Levee Mile	13.51
Location	Land Side
Category	Earthen Levee
Item	Encroachments

Grape vines within 10' from landside toe of levee from LM 13.39 to 13.51.

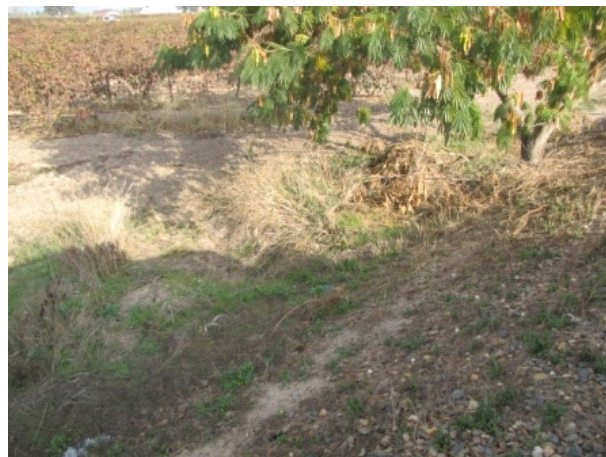
Levee Mile Report Line	120
Start Levee Mile	13.55
End Levee Mile	13.55
Location	Land Side
Category	Earthen Levee
Item	Slope Stability

View of a pit along the landward levee toe looking upstream.

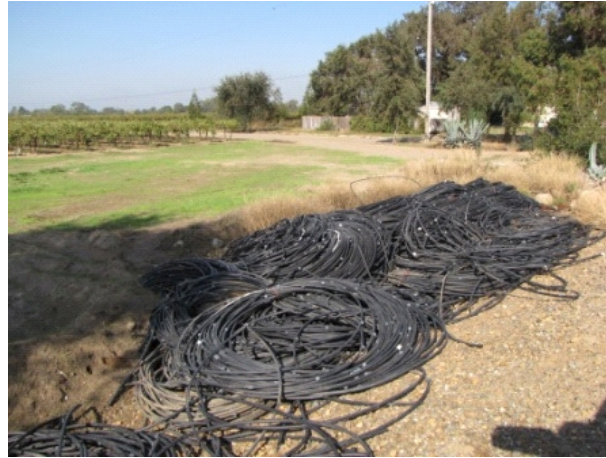
View of irrigation pipe on the landward slope.

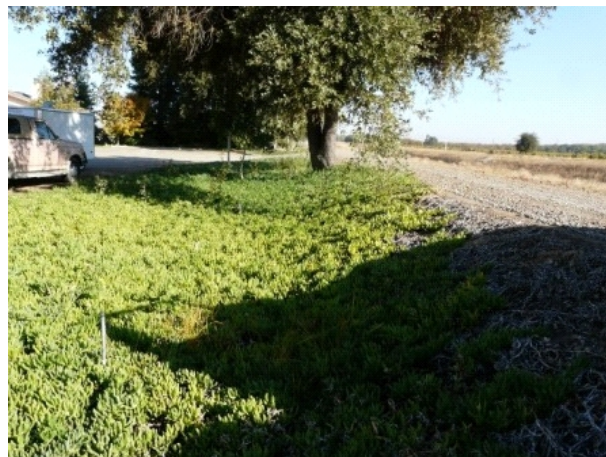
Levee Mile Report Line	128
Start Levee Mile	14.09
End Levee Mile	14.13
Location	Land Side
Category	Earthen Levee
Item	Encroachments

Landscaping on landside of levee from LM 14.09 to LM 14.13.

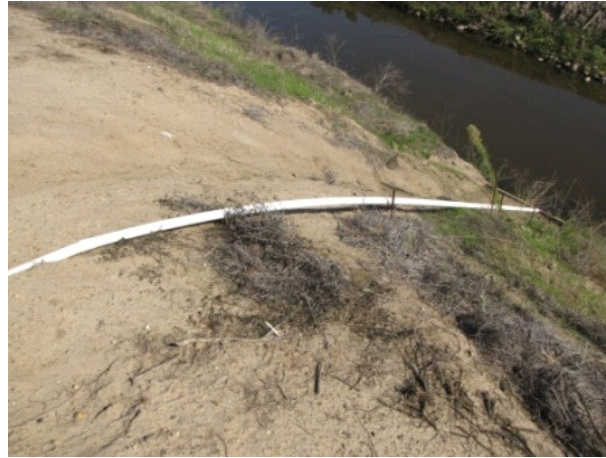
View of a pipe a landowner placed in the access road and waterward slope to pump water from the channel to irrigate their garden.

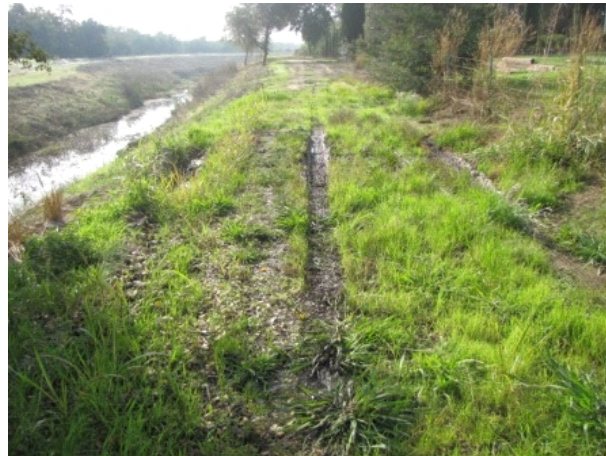
Levee Mile Report Line	132
Start Levee Mile	14.89
End Levee Mile	14.89
Location	Water Side
Category	Earthen Levee
Item	Crown Surface / Depressions / Rutting

View of a saturated portion of the access road with rutting, especially at the waterward hinge looking downstream.

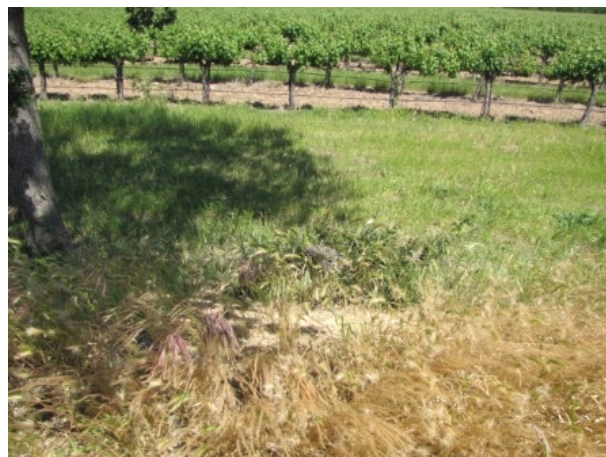
Levee Mile Report Line	136
Start Levee Mile	15.72
End Levee Mile	15.72
Location	Land Side
Category	Earthen Levee
Item	Trim / Thin Trees

View of a stump in the landward slope.

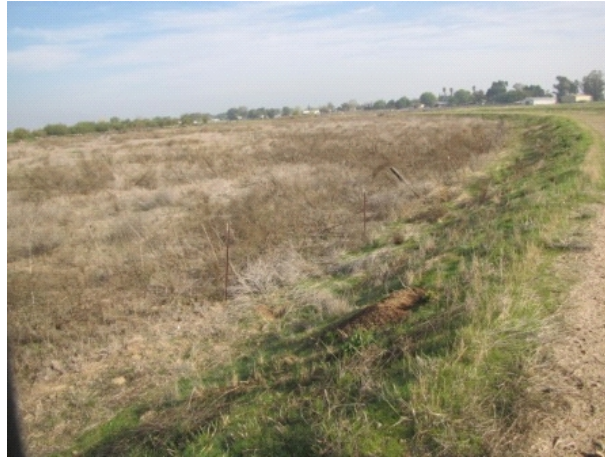
View of rodent activity along the landward slope looking upstream.

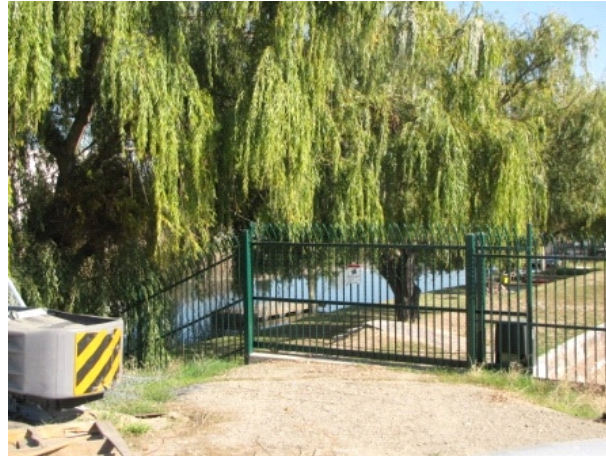
View of a open fence and gate across the crown at the current start of the unit looking upstream. Limited access has been provided.

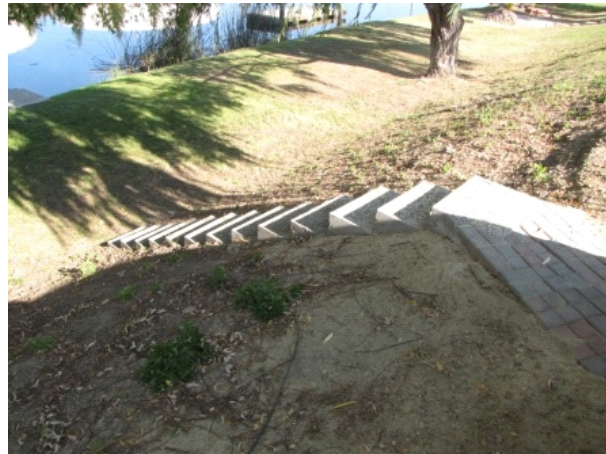
Levee Mile Report Line	2
Start Levee Mile	0.78
End Levee Mile	0.78
Location	Water Side
Category	Earthen Levee
Item	Encroachments

View of steps on the waterward slope of the levee looking upstream.

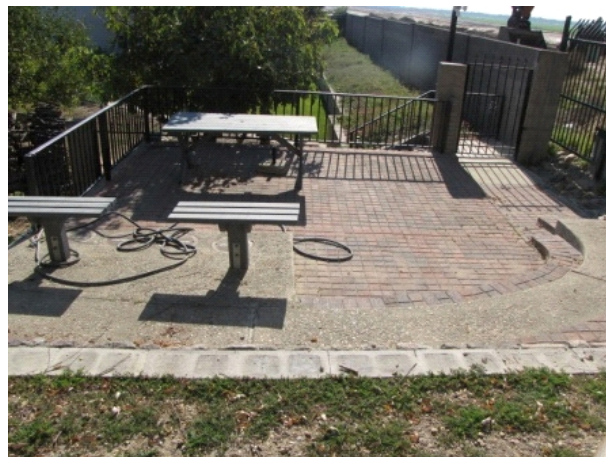
Levee Mile Report Line	3
Start Levee Mile	0.78
End Levee Mile	0.79
Location	Land Side
Category	Earthen Levee
Item	Encroachments

View of a patio with table, benches, and irrigation on the landward side of the levee.

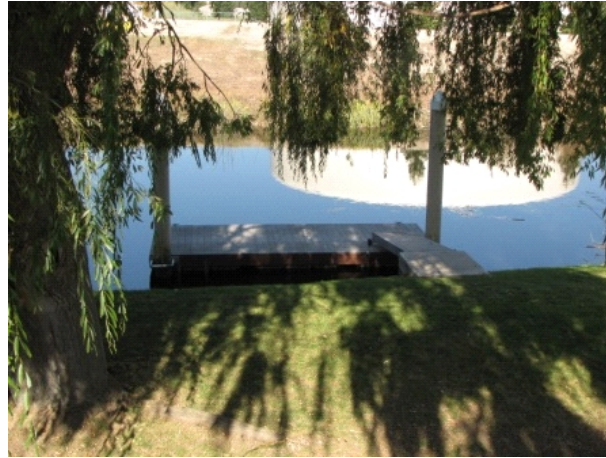
View of a dock off the waterward berm.

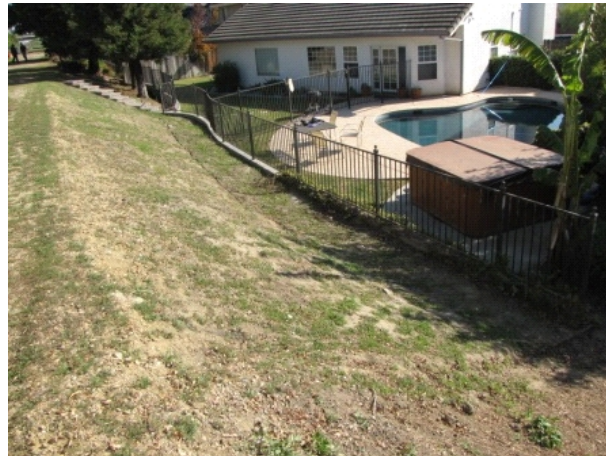
Levee Mile Report Line	7
Start Levee Mile	0.79
End Levee Mile	0.81
Location	Land Side
Category	Earthen Levee
Item	Encroachments

View of a fence on top of a retaining wall in the landward toe of the levee. Some landscaping and irrigation are also present.

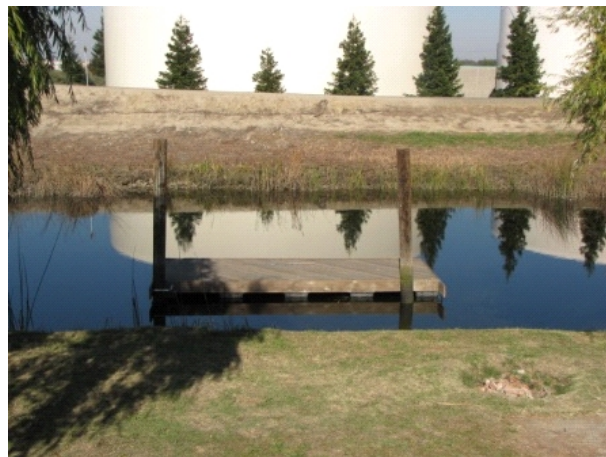
Levee Mile Report Line	8
Start Levee Mile	0.80
End Levee Mile	0.80
Location	Water Side
Category	Earthen Levee
Item	Encroachments

View of a dock off the waterward side of the berm.

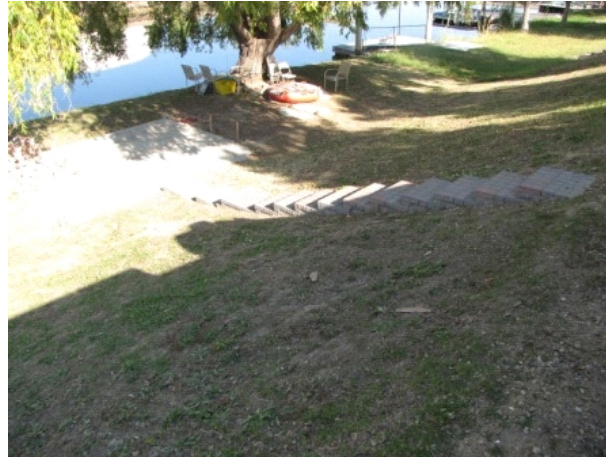
View of stairs and patio on the waterward slope and berm looking upstream.

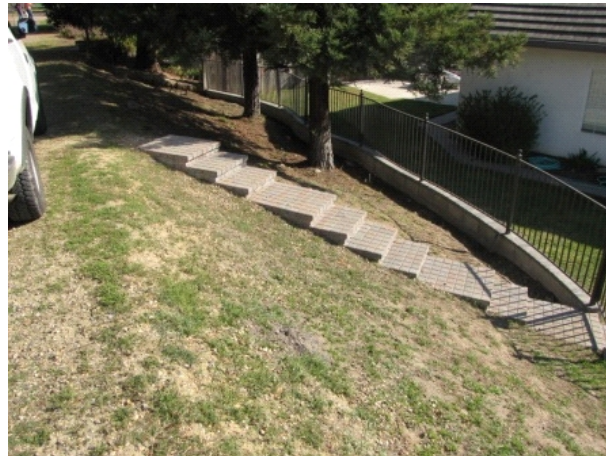
Levee Mile Report Line	10
Start Levee Mile	0.80
End Levee Mile	0.80
Location	Land Side
Category	Earthen Levee
Item	Encroachments

View of steps on the landward slope looking upstream.

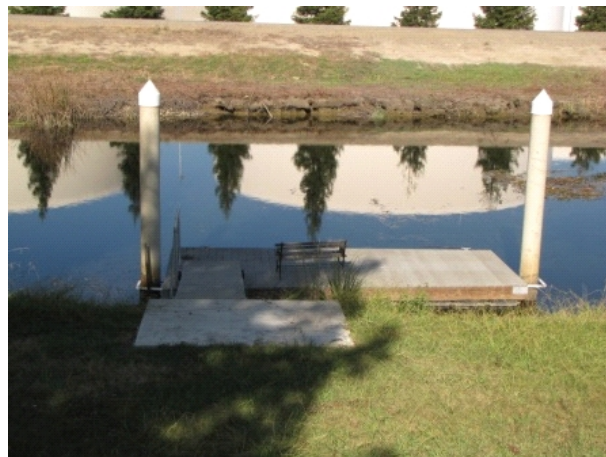
Levee Mile Report Line	11
Start Levee Mile	0.81
End Levee Mile	0.81
Location	Water Side
Category	Earthen Levee
Item	Encroachments

View of a dock on the waterward side of the berm.

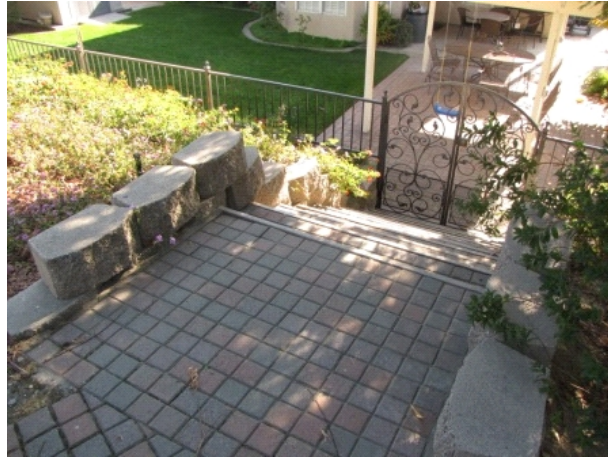
View of steps on the landward slope.

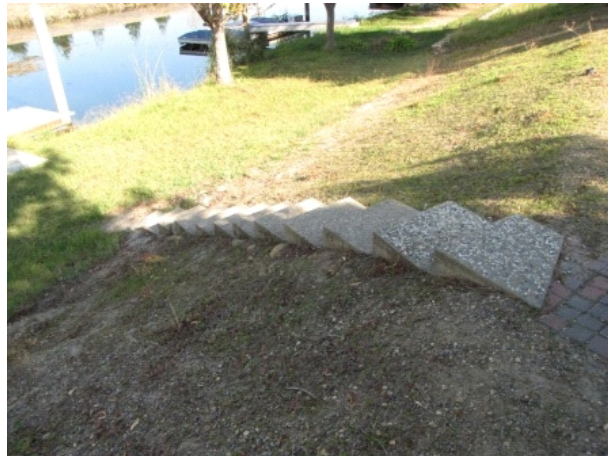
Levee Mile Report Line	13
Start Levee Mile	0.81
End Levee Mile	0.81
Location	Water Side
Category	Earthen Levee
Item	Encroachments

View of steps on the waterward slope looking upstream.

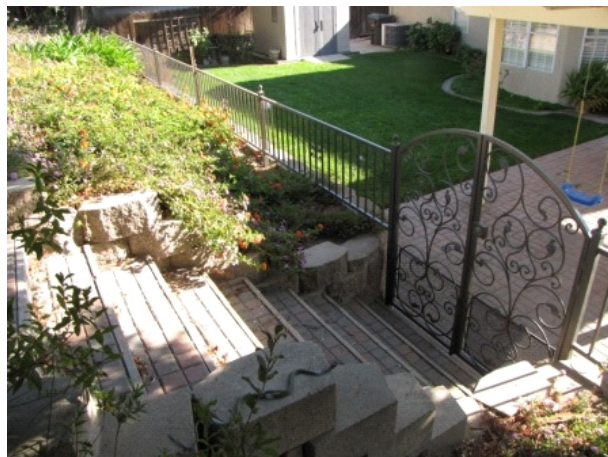
Levee Mile Report Line	14
Start Levee Mile	0.81
End Levee Mile	0.82
Location	Land Side
Category	Earthen Levee
Item	Encroachments

View of a open fence on a retaining wall in the landward toe of the levee looking upstream.

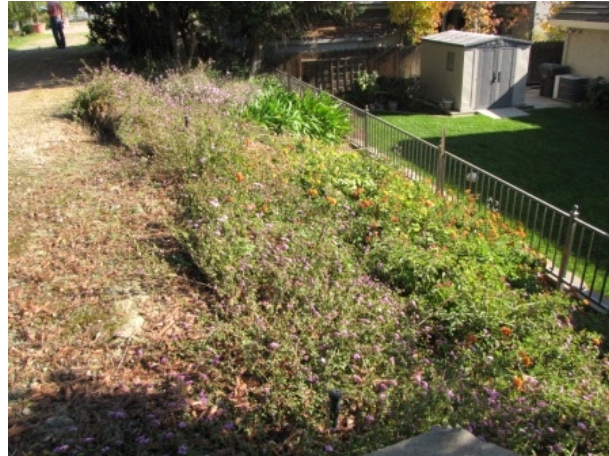
Levee Mile Report Line	15
Start Levee Mile	0.81
End Levee Mile	0.82
Location	Land Side
Category	Earthen Levee
Item	Encroachments
View of landscaping obstructing visibility and access and irrigation along the landward slope looking upstream.	
dpesaven_f_20100928_165.jpg

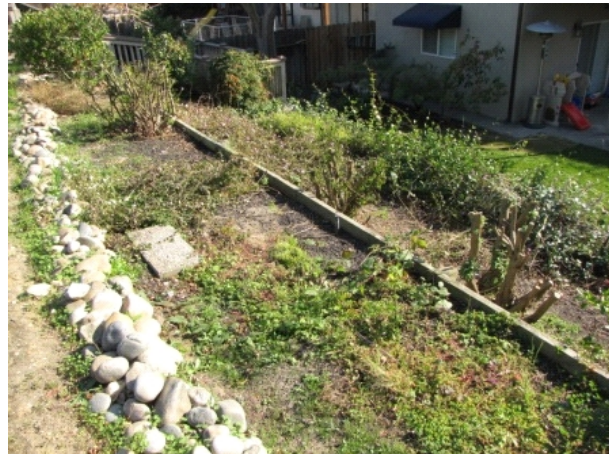
Levee Mile Report Line	18
Start Levee Mile	0.82
End Levee Mile	0.83
Location	Land Side
Category	Earthen Levee
Item	Encroachments
View of landscaping and irrigation along the landward slope looking upstream.	
dpesaven_f_20100928_169.jpg

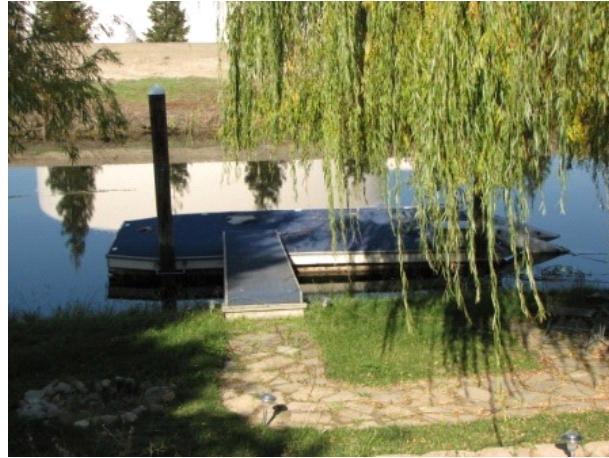
View of a dock and pathway on the waterward side of the berm.

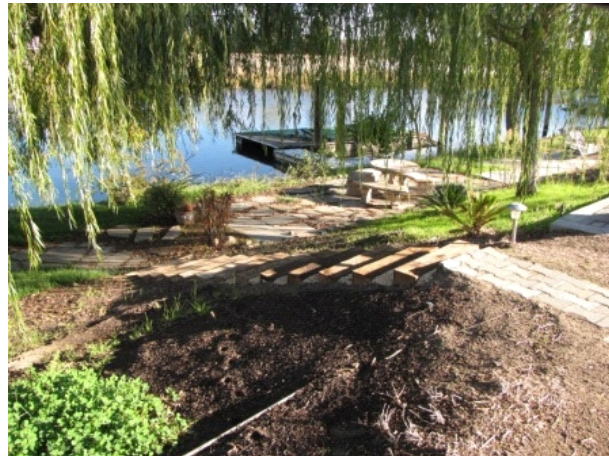
Levee Mile Report Line	21
Start Levee Mile	0.83
End Levee Mile	0.83
Location	Land Side
Category	Earthen Levee
Item	Encroachments

View of recently modified steps on the waterward slope of the levee looking upstream.

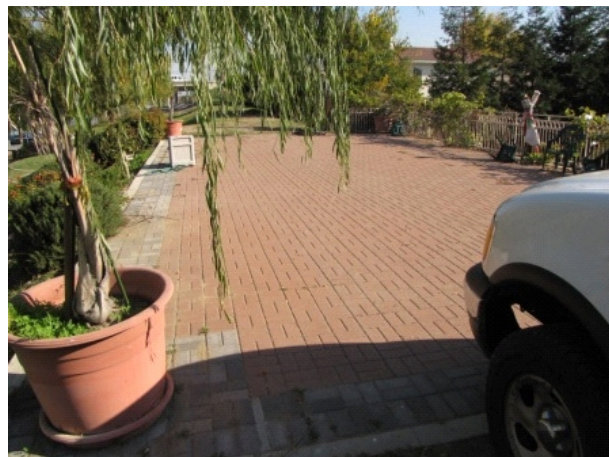
Levee Mile Report Line	22
Start Levee Mile	0.83
End Levee Mile	0.84
Location	Crown
Category	Earthen Levee
Item	Encroachments

View of pavers placed on the crown of the levee looking upstream. Potted landscaping and irrigation can also be seen.
